Case Study

application	Crack Retarding for Asphalt Overlay
location	Old US52, south of Winston Salem, NC
product	TruPave® Paving Mat

job owner	NCDOT
engineer	NCDOT
contractor	Larco/Landsaver

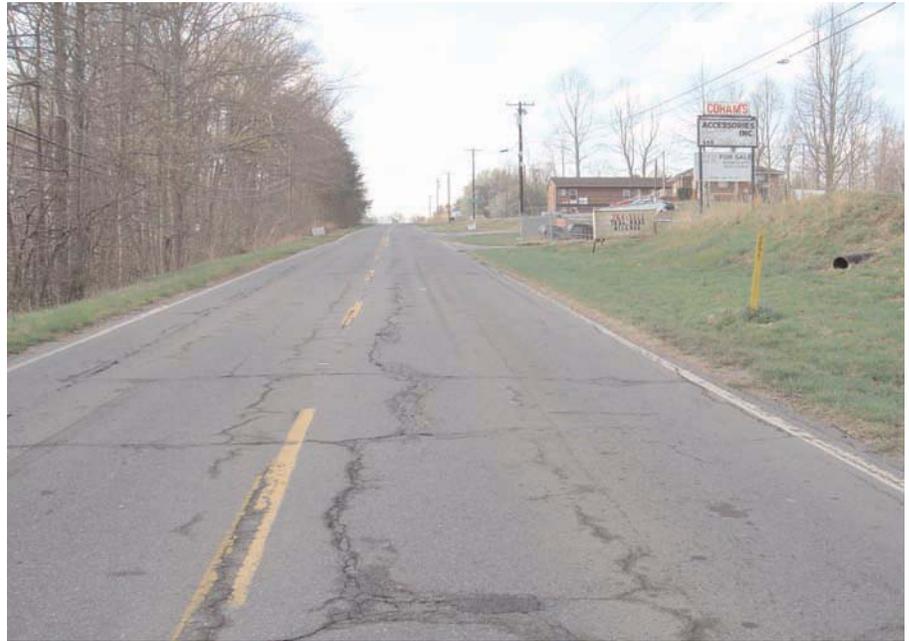
US52 before construction.

North Carolina Department of Transportation (NCDOT) had a 2 mile section of US52, south of Winston Salem where they wanted to find a way to retard reflective cracking over an existing Portland Cement Concrete (PCC) pavement that had previously been overlaid with a Hot Mix Asphalt (HMA). The joints from the old PCC pavement had reflected back through rather quickly, creating transverse and longitudinal cracking in the overlay. There was also major block cracking in the existing HMA.

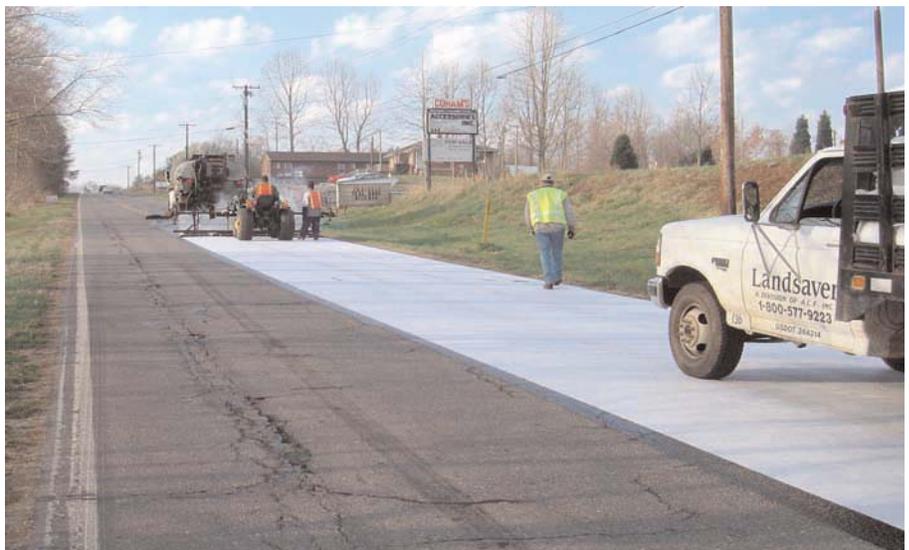
Installation of TruPave® Paving Mat on US52.

In March of 2004, work started on the TruPave® Paving Mat installation. Landsaver placed the paving mat tack coat (PG64-22) at the specified rate and laid the TruPave® Paving Mat. Larco, the paving contractor on the project, followed behind with the 2" thick HMA overlay. NCDOT also had Larco place a test section with a 2" thick HMA overlay and no TruPave® Paving Mat.

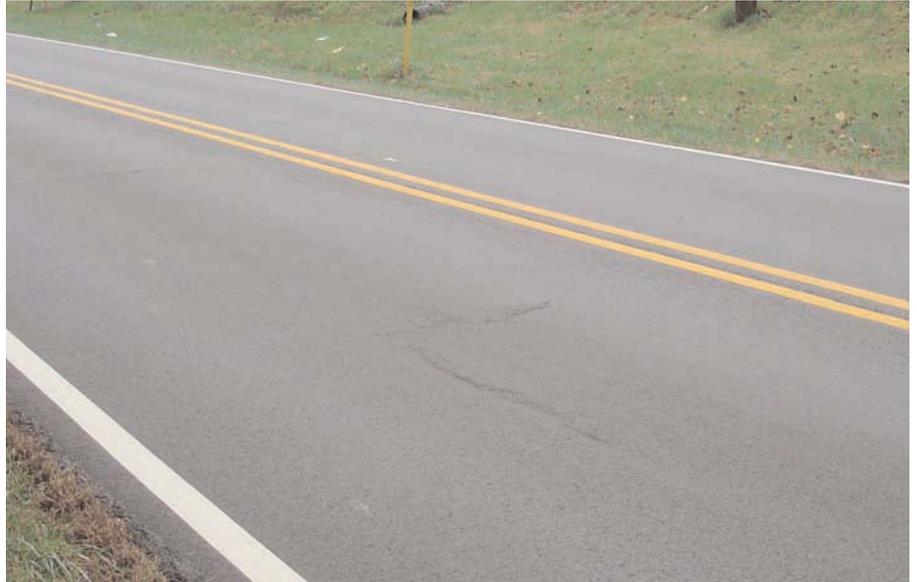
Roadway in November of 2004.

Late in 2004, on return to the site, the control section had transverse, longitudinal, and heavy block cracking showing through the HMA overlay. The cracks stopped immediately along the TruPave® delineation.

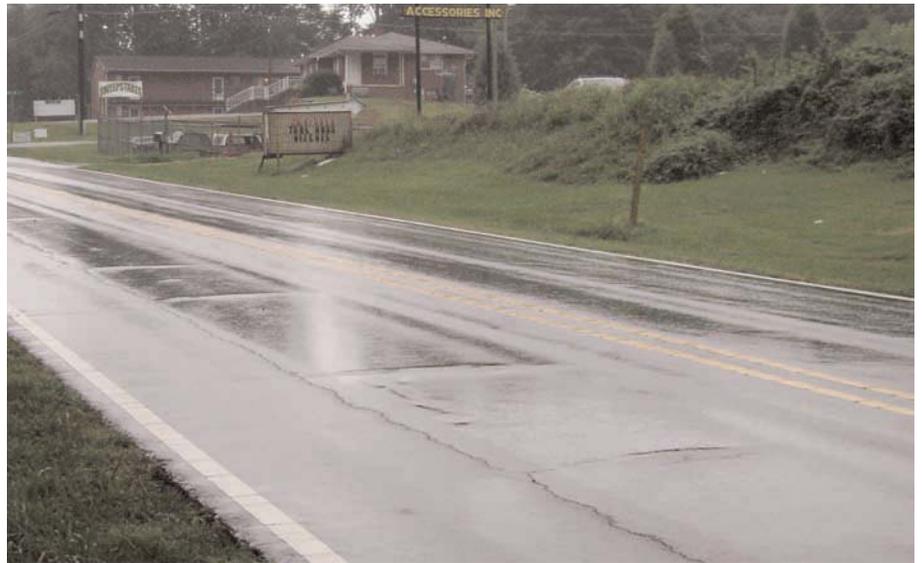
Roadway in August of 2008.

With most recent follow-up to the site in 2008, the control section has continued to deteriorate while the TruPave® Paving Mat section is only now starting to see typical top down cracking that most asphalt pavements experience.
